Date : 15/04/2017

Repair and rewire Zeiss Vertometer S/N 96041

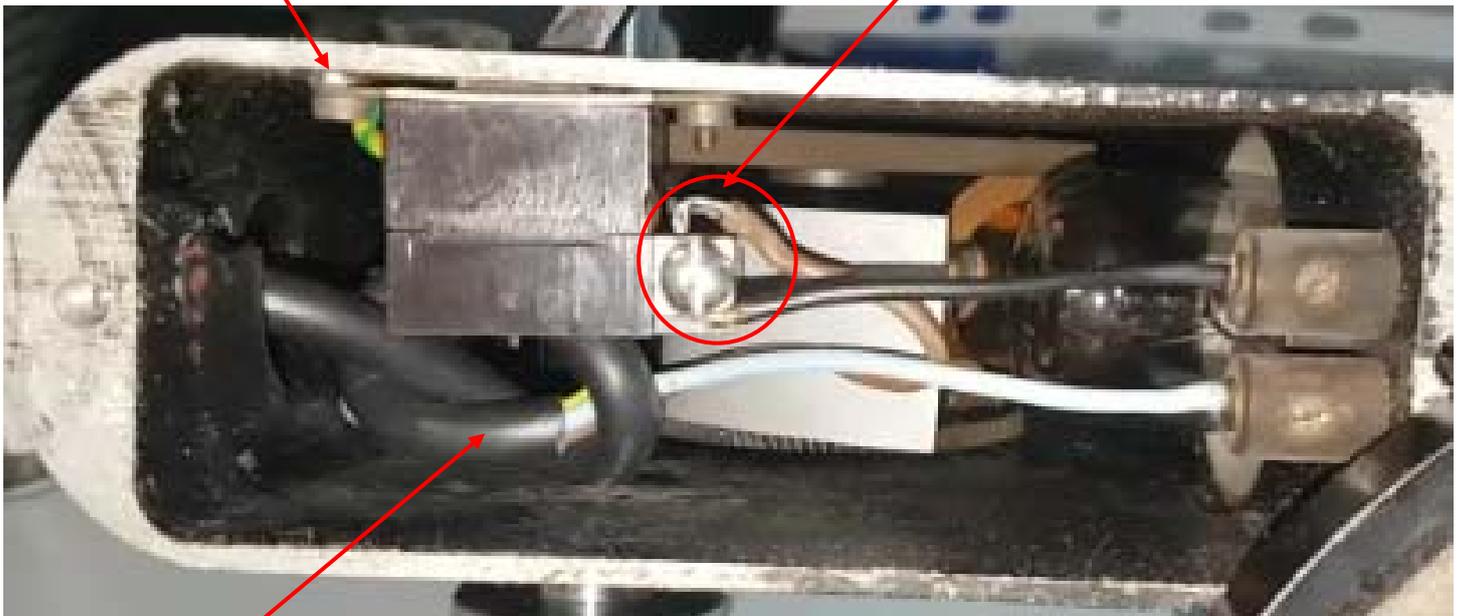
An investigation into the flickering light, revealed that the mains power wires had loosened from the switch terminals and were floating.

Please note if these wires had made contact with the lensmeters metal body, the whole instrument would have become live.

Note the earth wire is just sitting under the switch

Note the Active wire has come loose and is just floating

Note the wire is just tied in a knot and not clamped

I have rewired the whole unit, have removed the screw terminals and have soldered all the connections to ensure this cannot re-occur.
